**TYPE A ACCIDENT
INVESTIGATION BOARD REPORT
OF THE JULY 28, 1998
FATALITY AND MULTIPLE INJURIES
RESULTING FROM RELEASE OF
CARBON DIOXIDE
AT
BUILDING 648, TEST REACTOR AREA
IDAHO NATIONAL ENGINEERING AND ENVIRONMENTAL
LABORATORY**

September 1998

**Office of Oversight
Environment, Safety and Health
U.S. Department of Energy**

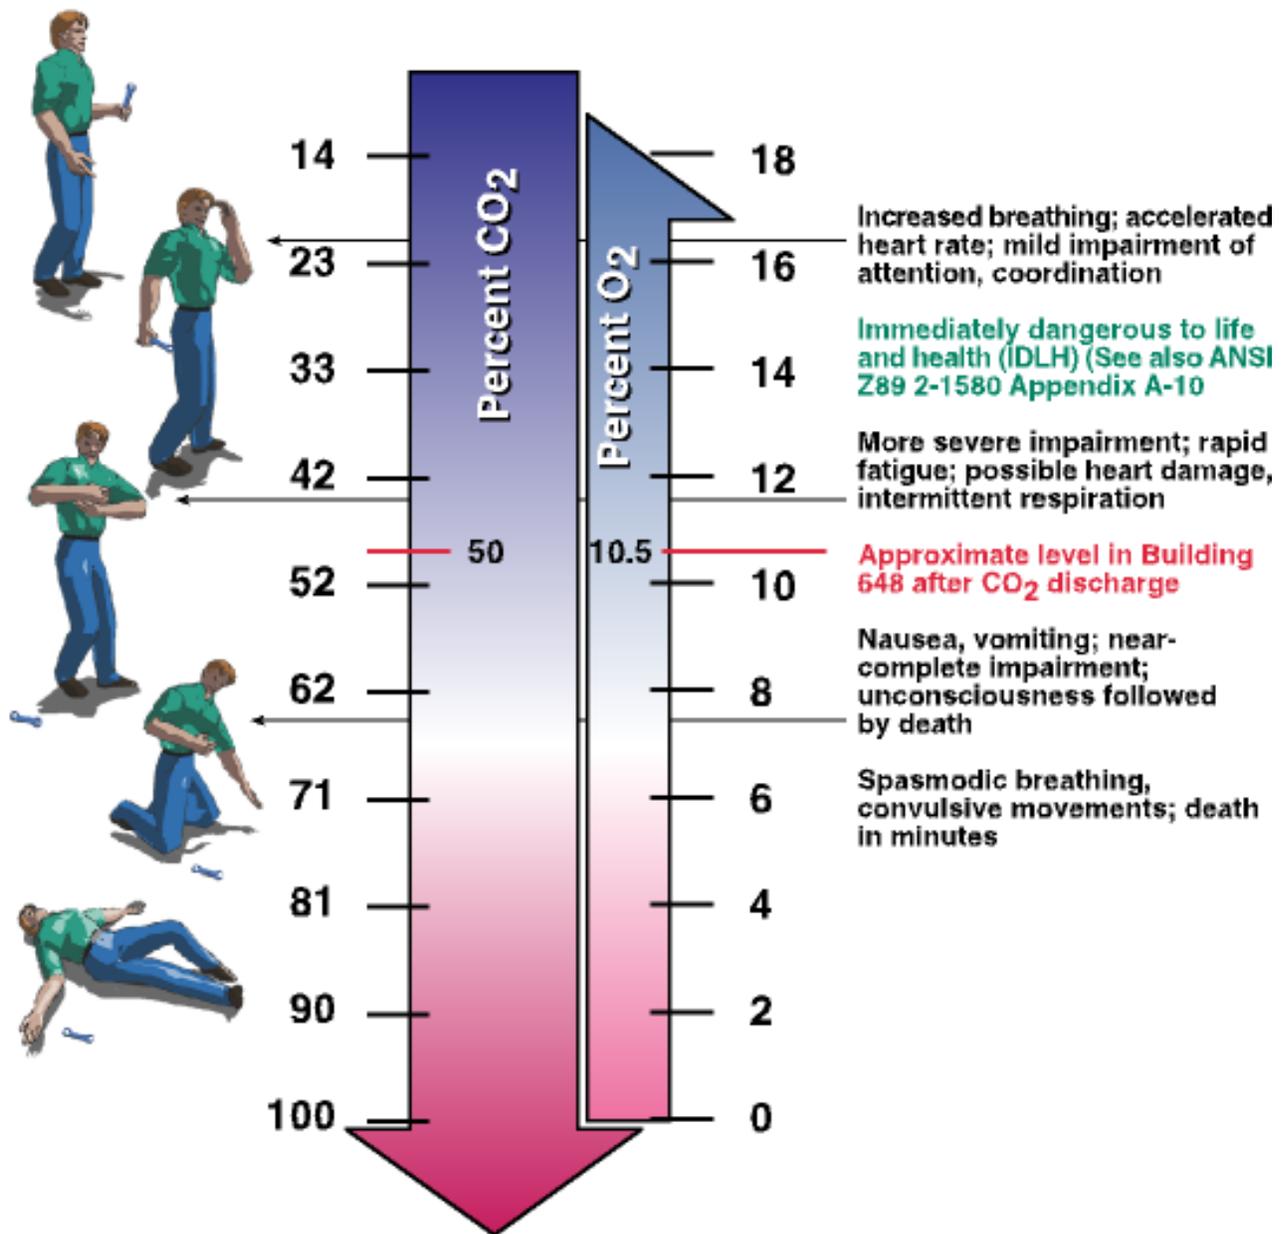
Figure 2-1. Physiological Effects of CO₂ Exposure

The percentage of CO₂ in the building following the accidental initiation of the fire suppression system was estimated at approximately 50 percent. This is well above the 30 percent minimum concentration necessary for fire protection and is lethal to occupants or individuals, as shown in Figure 2-1. At 50 percent CO₂, the oxygen levels within the building would be approximately 10.5 percent, well below that needed to sustain life. This atmosphere can result in symptoms of nausea; vomiting; near-complete impairment; unconsciousness followed by death and spasmodic breathing; convulsive movements; and death in

minutes. The personnel in the building during the accident experienced vomiting, impairment of actions, spasmodic breathing seizures, and unconsciousness, and their attempts to escape were hindered by the disorienting physiological effects of CO₂.

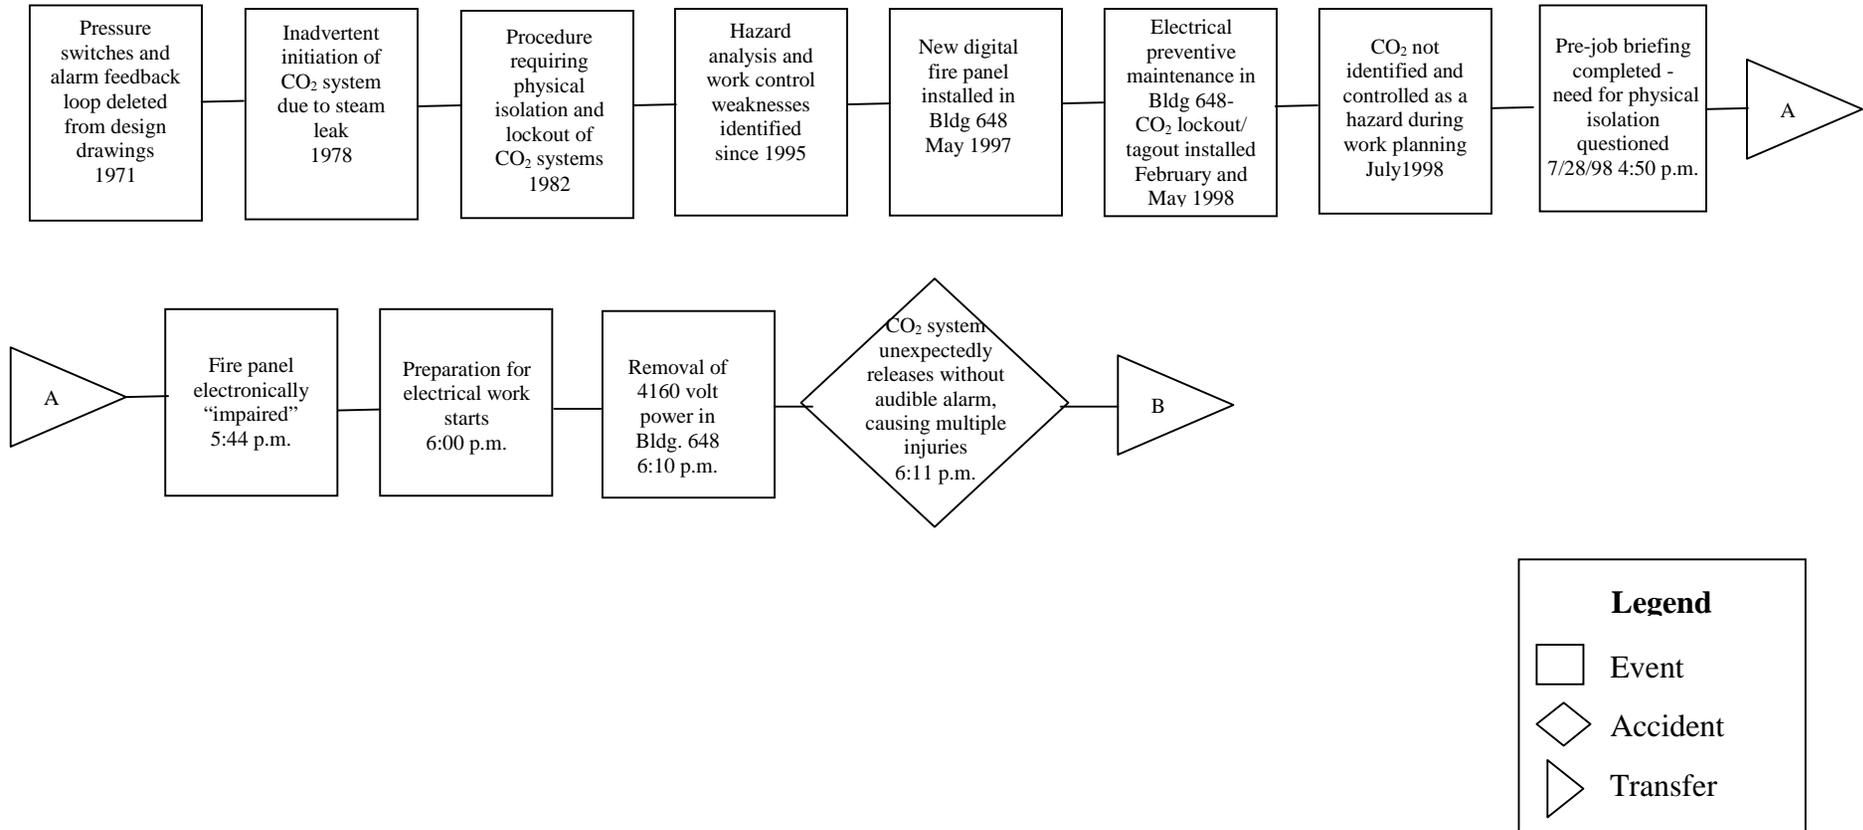
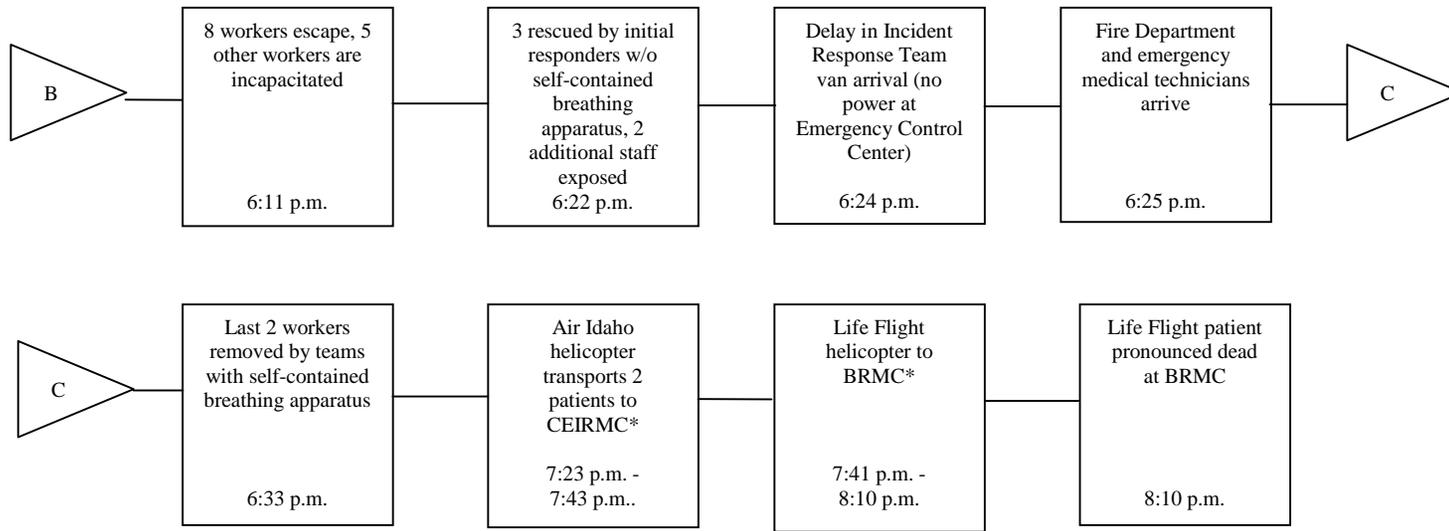
Figure 2-2. Summary Events Chart and Accident Chronology

Figure 2-2 summarizes the chronology of significant events leading up to and after the accident.

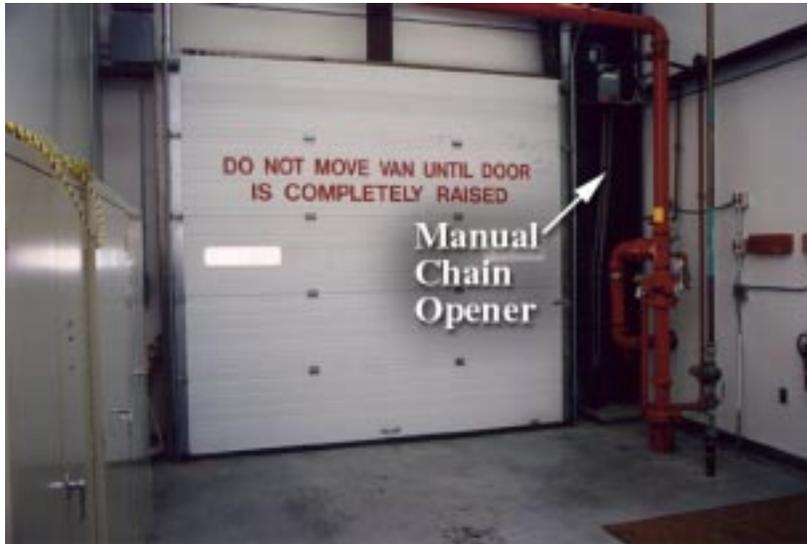
Exhibit 2-6. Emergency Control Center Door

Attempting to ventilate the building, two individuals went to the south entrance and were able to jerk open the normally locked doors since the lock was broken. This attempt resulted in rescuing an additional worker lying under the window west of the doors (O-1); during an earlier attempt, he had been obscured by the dense CO₂ fog. Since he was not breathing, cardiopulmonary resuscitation (CPR) was initiated immediately. This was the same worker who had tried to escape by breaking through a glass window, and his severe arm injuries also required immediate medical attention. One individual also went through the ETR Building to reach the exit door in the northeast corner of the switchgear room and chained this door open for ventilation. Two other injured workers in this general area were probably not observed because of the fog and the absence of any temporary or emergency lighting in this corner. One was later rescued and revived (F-1), and the other died en route to the hospital (E-3).

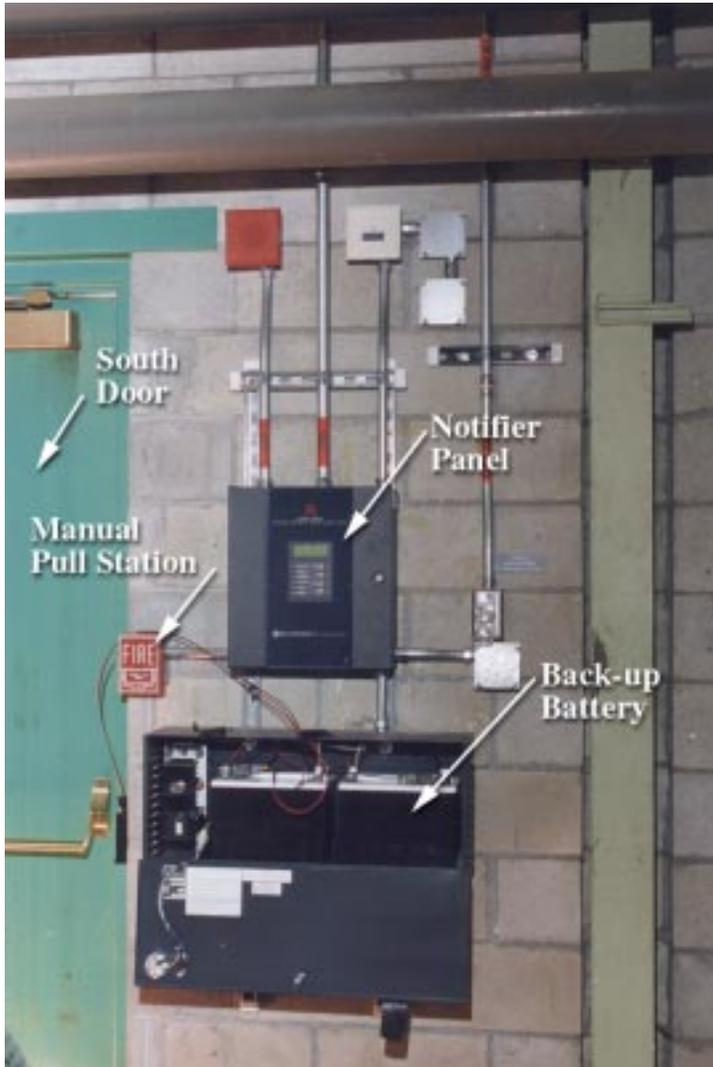
Exhibit 3-1. Notifier Fire Alarm Panel

The fire alarm system controls the evacuation alarms and the carbon dioxide discharge system.

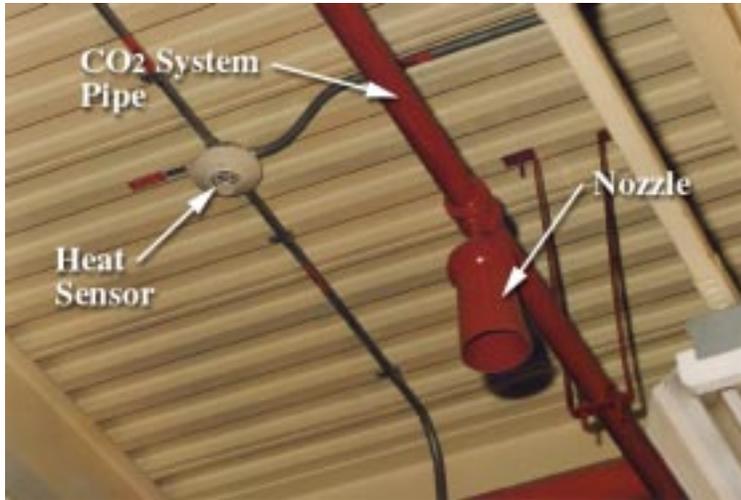
Exhibit 3-4. Overhead CO₂ Discharge Nozzle

together by manifolds, all of which are located in a CO₂ shed attached to the south side of the building (see Exhibit 3-2). The CO₂ manifolds connect to a system of piping and ceiling nozzles inside Building 648.

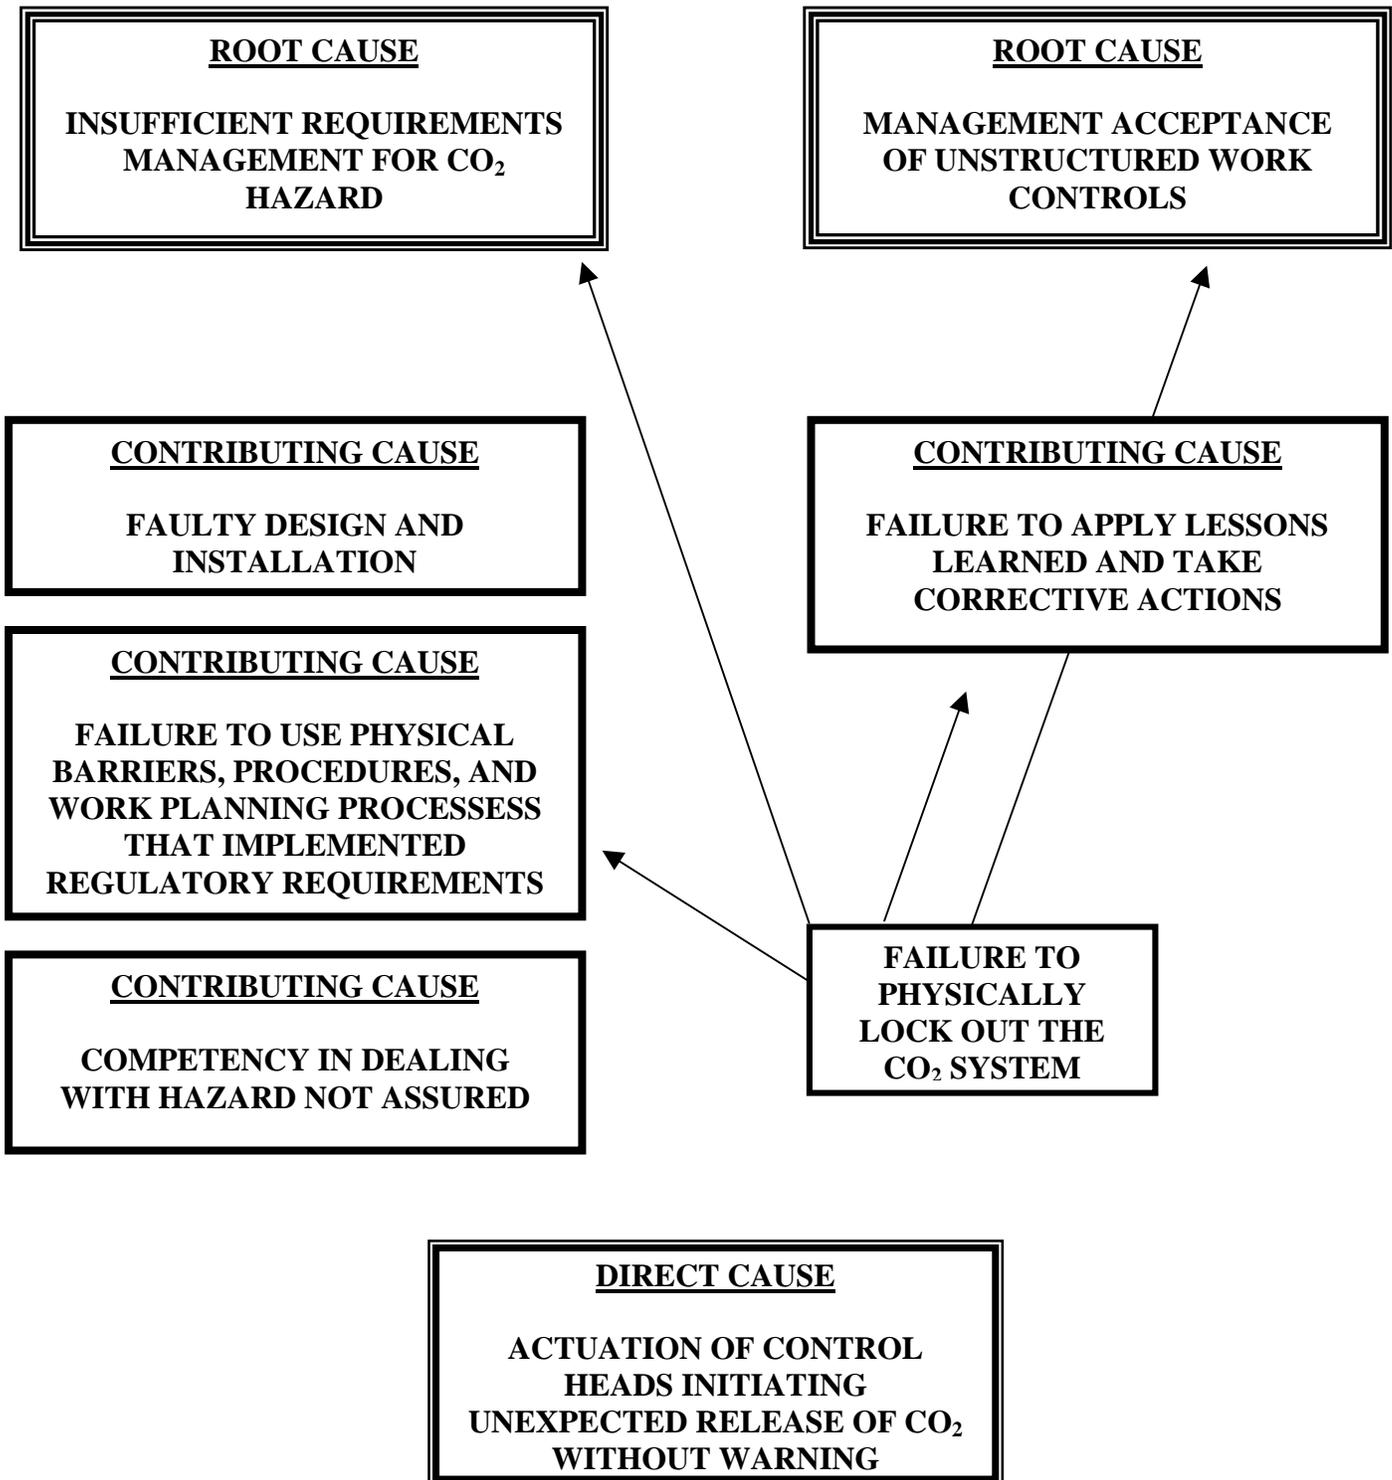
**FIGURE 4-2.
CAUSAL FACTORS IMPACTING ACCIDENT MITIGATION**

There were other contributing causes that impacted accident mitigation (i.e., failure to install a warning alarm and failure to adequately evaluate the impact of infrastructure reductions on worker safety). These causal factors are discussed in Sections 3.2 and 3.5 of the report, where more facts regarding them are presented. Section 4.0 discusses how they relate to the root causes of the accident, and Figure 4-2 depicts this relationship. See these sections for further discussion.

Root Cause Determination. The narrative in this section is structured to correspond with the logic used to arrive at all the causal factors for the accident, including the root causes. Since the lower tier contributing causes lead to root causes, they are discussed first. After discussion of the contributing causes, the root causes are identified with a brief analysis. The Board used tier diagramming to arrive at the root causes, which logically flow from the contributing causes. This relationship is depicted on Figures 4-1 and 4-2.
